# Army Lodging Wellness Recommendation

## Final Submittal - Fort Buchanan

May 17, 2004

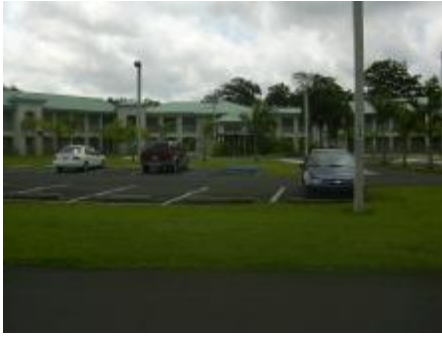
*Bldg 678  
Main Lodging Facility  
Ft. Buchanan, PR*

Because the Sum of the Condition Assessment and Upgrade Costs to Replacement Cost Ratio is less than 50.00%, repair, upgrade, and continued use of Building 678 is recommended.

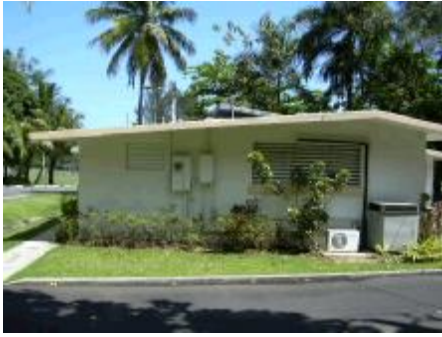
*Bldg 801  
Front View  
Ft. Buchanan, PR*

Because the Condition Assessment to Replacement Cost Ratio is greater than 50.00%, repair of Building 801 is not recommended.

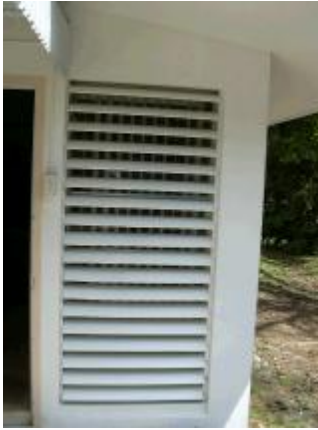
Bldg 801  
Typical Window  
Ft. Buchanan, PR

- Analysis: The original metal windows are single pane, single hung and not low E with metal shutters and are in poor condition.
- Recommendation: Replace all of the windows.

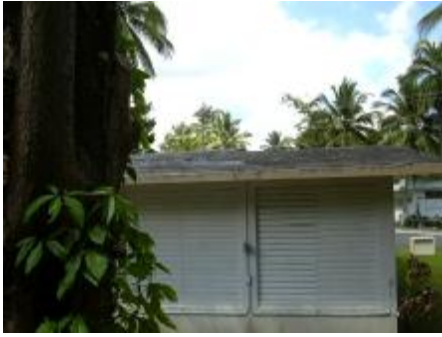
***Bldg 801***  
***Failing Roof Covering***  
***Ft. Buchanan, PR***

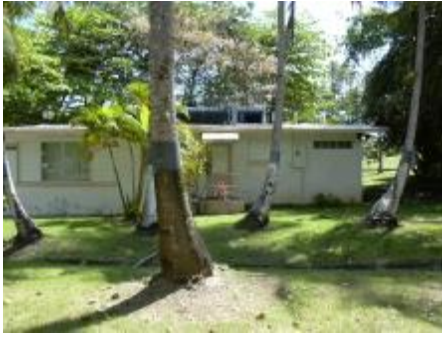
*Bldg 802  
Side View  
Ft. Buchanan, PR*

Because the Condition Assessment to Replacement Cost Ratio is greater than 50.00%, repair of Building 802 is not recommended.
